Triverus Cleaning Technology Demonstration Report

10/18/2019

University of New Hampshire, Durham, NH

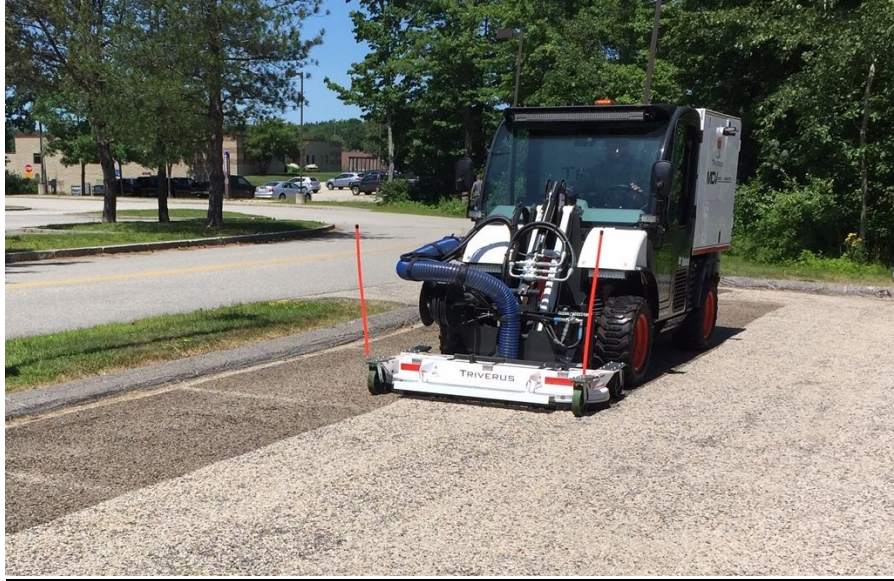
Technology description from the manufacturer: “The Triverus Municipal Cleaning Vehicle (MCV) integrates Triverus 3800 PSI spray cleaning and recovery technology onto a Bobcat® Toolcat™ all-wheel steer carrier. This packaging provides maximum flexibility for surface cleaning in congested areas such as airport ramps, airside loading bridge and terminal areas, walkways, dock areas, and enclosed parking structures. An overall height of 81 inches gives the MCV free reign in almost any covered parking area.”

Figure 1: Triverus MCV cleaning West Edge Porous Asphalt (UNHSC).

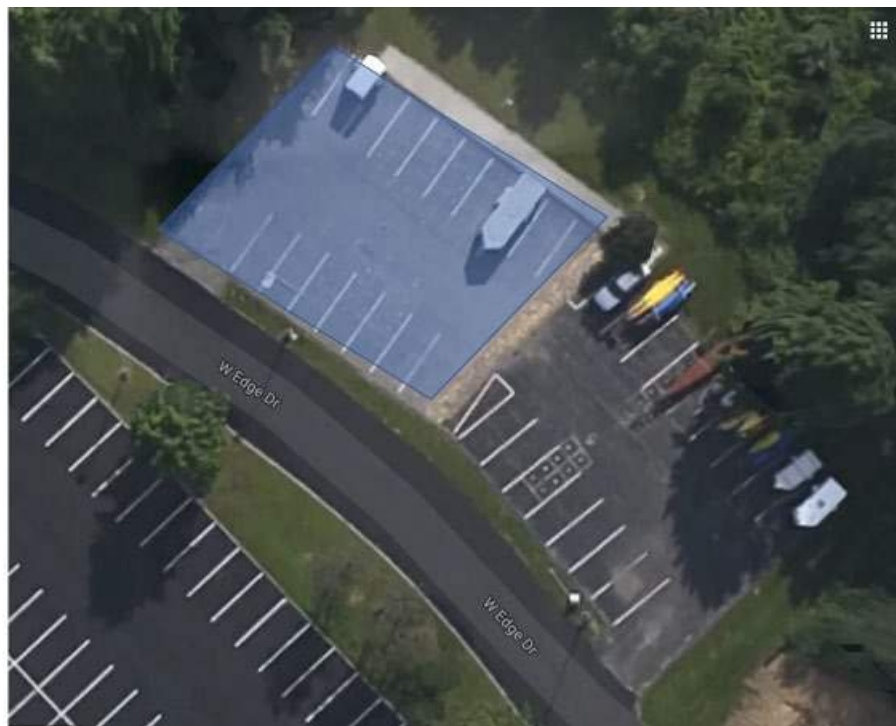
Figure 2: West Edge Porous Asphalt Parking Lot

The West Edge Porous Asphalt Lot: The west edge porous asphalt lot is 14 years old and received maintenance for at least the first 5 years of operation. Since 2010, minimal studies and maintenance have taken place. The area is approximately 5,000 square feet in size and had an average pre-cleaning infiltration rate of 3 in/hr. Due to the variability of the testing method any permeable pavement with a surface infiltration rate less than 10 in/hr is considered failed from a hydraulic perspective. The average post-cleaning infiltration rate was 94 in/hr as shown in Figure 3, which is functional and effectively restored.

The restoration process was inevitably longer and more time-intensive than typical routine maintenance. The cleaning took approximately 6 hours, and 150 lbs of coarse sediment were removed from the area.

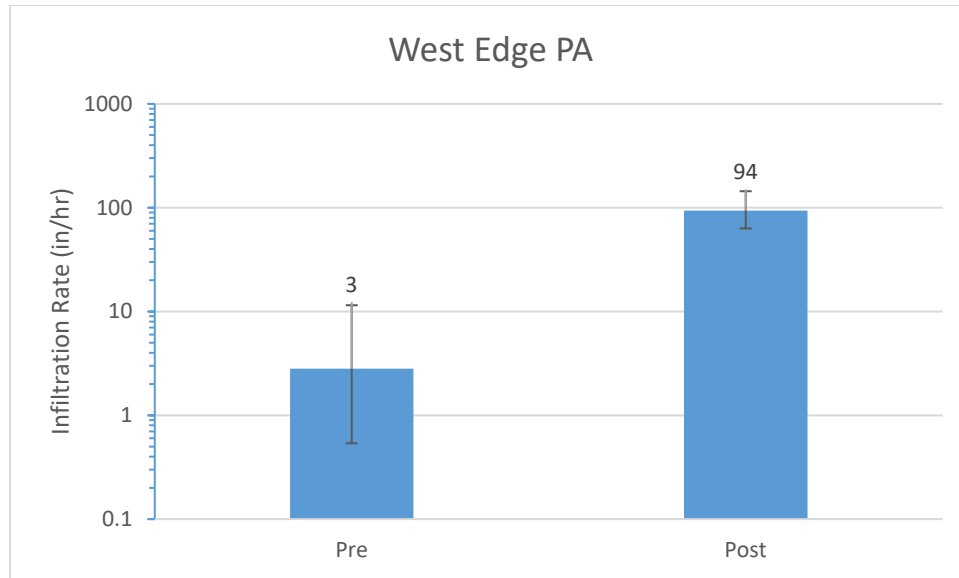
Figure 3: Pre and post-cleaning surface infiltration rate measured summer of 2019. Numbers above each blue bar represent the mean infiltration rates, and error bars show the range of values (minimum to maximum). The number of tests (n) were 12 and 6 for pre- and post-cleaning, respectively.

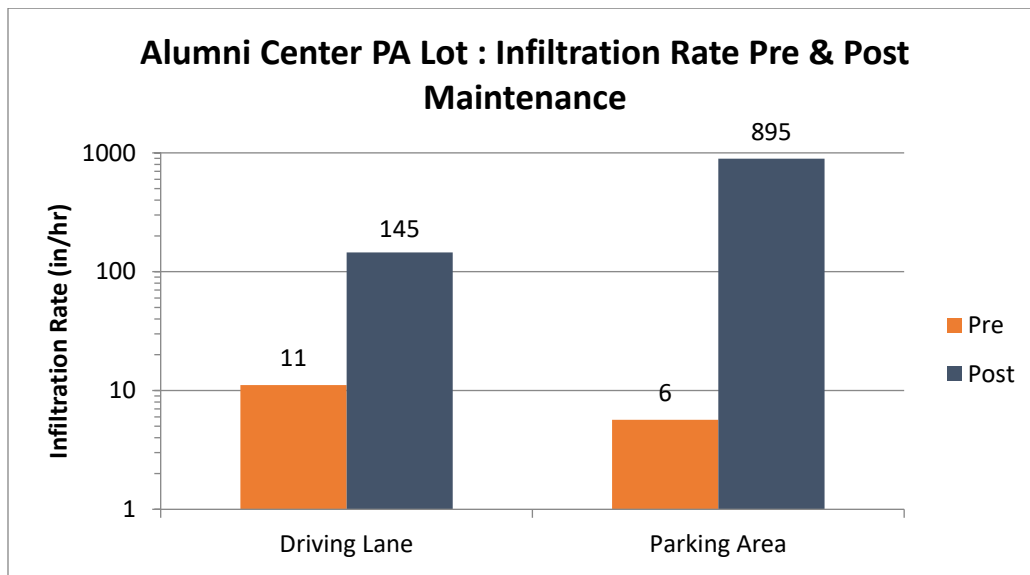
In 2015, a small test area of approximately 200 square feet in a parking spot and 200 square feet in a driving lane was conducted to assess restoration potential. The cleaning was conducted by UNHSC staff and consisted of low angle power washing into a vacuum. The overall restoration work took two staff approximately 2 hours per location. The experiment demonstrated the restoration potential of the technology however at just over 50,000 square feet the effort using staff and handwork is not insignificant (~125 hours for two staff). The infiltration results from this testing are shown in 4.

Figure 4: 2015 restoration experiment of the Alumni Center Porous Asphalt

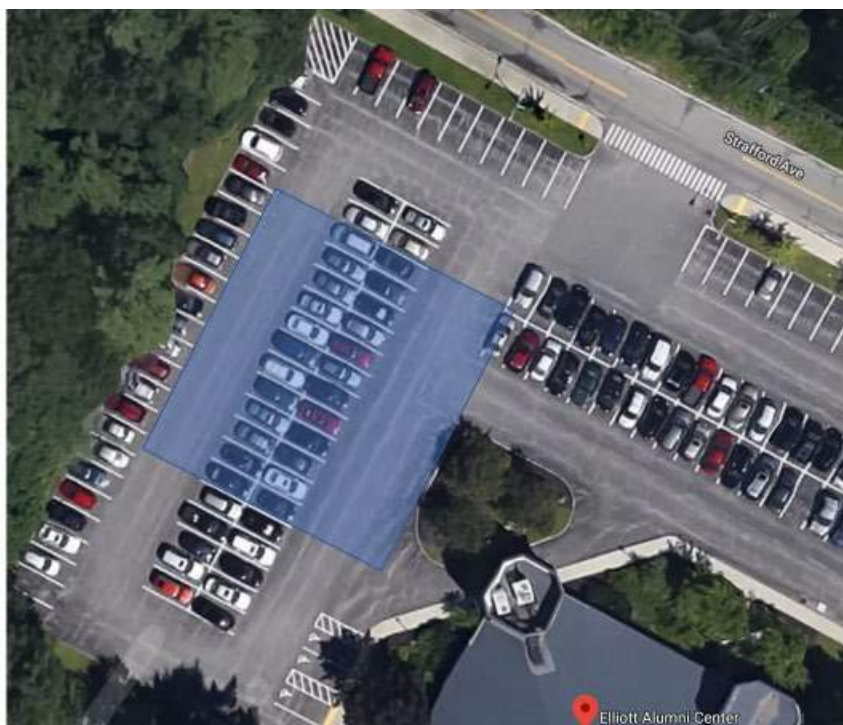
Figure 5: Elliot Alumni Center Porous Asphalt Parking Lot

The area tested by Triverus MCV was approximately 3,575 square feet in size and had an average pre-cleaning infiltration rate of 3 in/hr (see figure 5). Due to the variability of the testing method, any permeable pavement with a surface infiltration rate of less than 10 in/hr is considered failed from a hydraulic perspective. The average post-cleaning infiltration rate was 84 in/hr as shown in Figure 6, which is functional and effectively restored.

The restoration process is inevitably longer and more time-intensive than typical routine maintenance. The cleaning took approximately 4 hours, and 350 lbs of coarse sediment were removed from the area. The decrease in cleaning time from the West Edge lot was due in part to process efficiencies. Additional time reductions could be realized, particularly with respect to MCV support with a vactor truck to reduce downtime associated with the disposal of removed material and refilling the water reservoir on the MCV. The detailed characterization and testing of the efforts take time and reduce restoration efficiency as well.

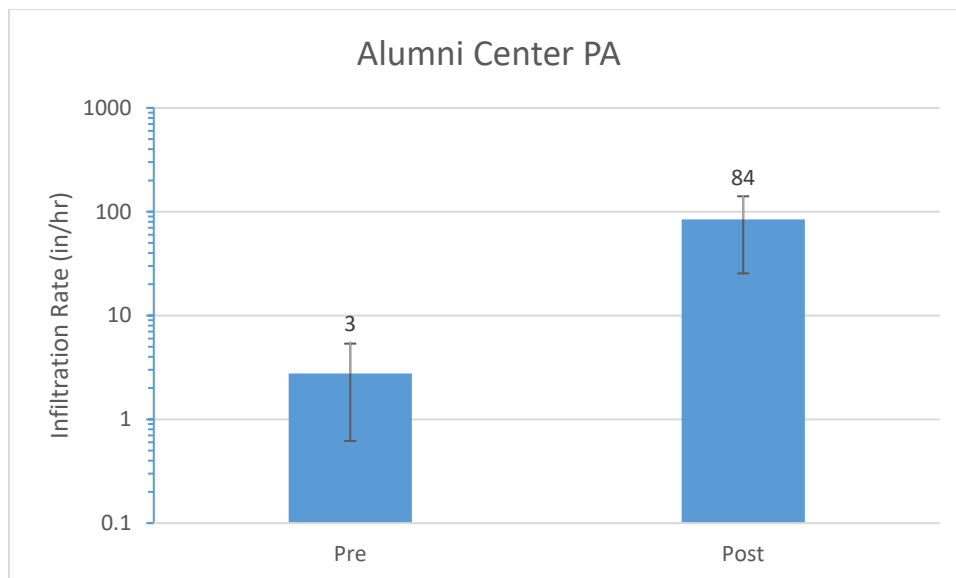
Figure 6: Pre and post-cleaning surface infiltration rate measured summer of 2019. Bars represent the mean infiltration rates, and error bars show the range of values (minimum to maximum). The number of tests (n) were 12 and 6 for pre- and post-cleaning, respectively.

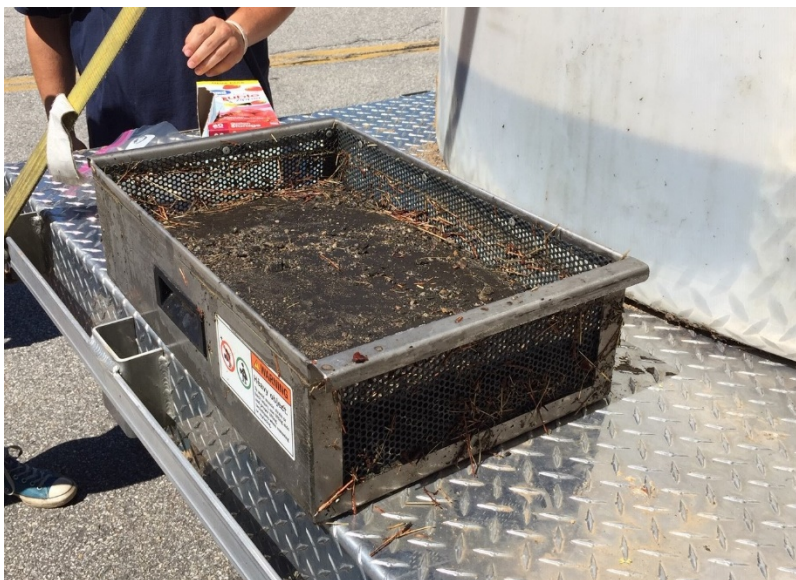
Water Quality: The removed material is separated in the MCV by a coarse screen and tray to hold coarse solids as the water and fines pass into a holding tank in the MCV. Once full, the tray with solids may be removed to be disposed of, and the water/fines slurry is pumped out to be filtered and disposed of properly. The tray of coarse solids is shown in Figure 7 after several passes on the West Edge porous asphalt.

Figure 7: The coarse solids collected in the solids tray after several passes on the West Edge PA.

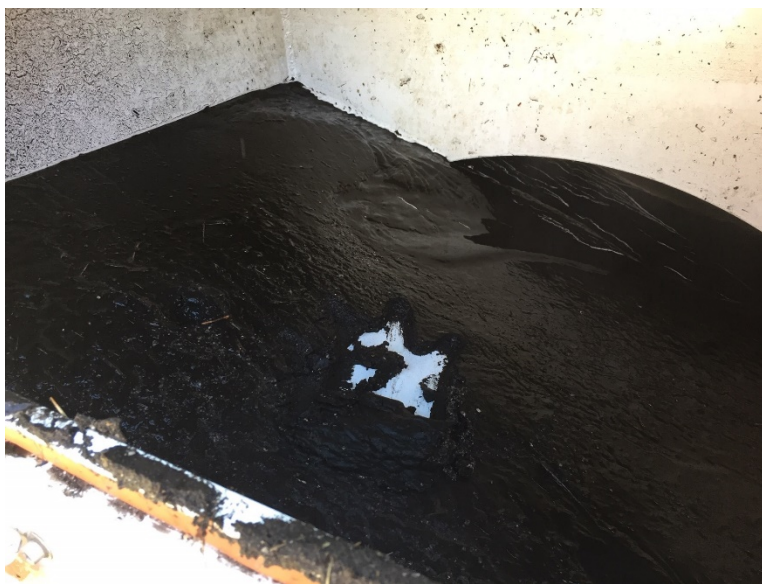
The coarse solids were weighed and samples collected for laboratory analysis. Grab samples of the water slurry were taken and sent as a composite sample for laboratory analysis. A picture of the fines after the water was pumped out of the holding tank is shown in Figure 8.

Figure 8: The fines collected in the collection tank after coarse solids were removed in the tray screen and the water was pumped out. Note the center where the fines were moved to show the bottom of the tank (white).

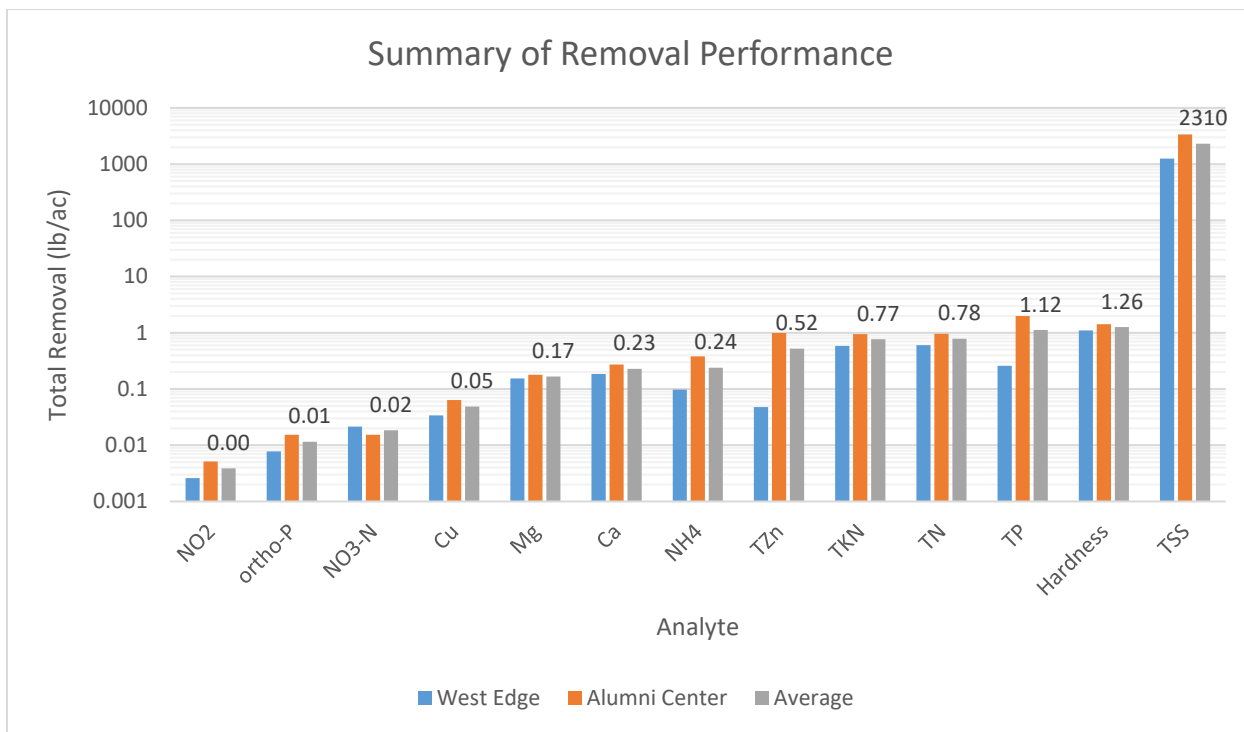
Figure 9 shows the same summary of performance in graphical form. Note the logarithmic scale, and NH₄ for the West Edge and NO₂ for both sites are not graphed (BDL).

Figure 9: Summary of performance by site for the total removal of the solids, water, and slurry. Not the logarithmic scale.

Overall, the restoration effort was extremely successful. Our research supports further exploration of restoration activities followed by more routine operation and maintenance such as vacuum sweeping twice per year. This data also reveals some significant differences in the pollutant partitioning between the liquid and solid fractions of the removed materials. It underscores the importance, particularly in nitrogen sensitive areas, of properly treating the removed waste materials.
