TRIVERUS  
**MCV** MUNICIPAL CLEANING VEHICLE

# PERVIOUS PAVEMENT MAINTENANCE GUIDE

**TRIVERUS**  
CLEANING & ENVIRONMENTAL SOLUTIONS

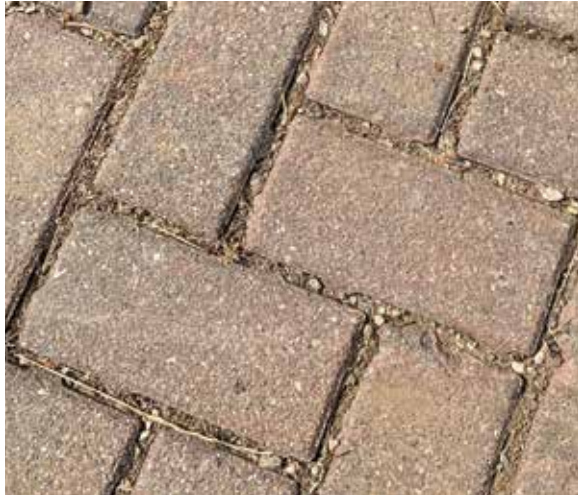
**Before**

Foreign material and organic deposits such as leaves, dust, and pine needles accumulate on pervious pavement. “Macro-plugging” forms a blocking layer on top of the pavement’s porous structure, preventing water from penetrating the surface. Furthermore, if these organic deposits are not removed regularly, they begin to degrade and begin to plug below the pervious pavement’s surface. This process limits the functionality of the pervious pavement, leading to increased water runoff, less groundwater recharge, and more contribution to stormwater.

In the *Before* photo to the left, organic deposits are clearly visible on top of the interlocking pervious pavers and aggregate. In the *After* photo, the pavers have been swept and cleaned, restoring the functional permeability and leaving behind only the aggregate between the pavers. All types of pervious pavement must be cleaned to maintain permeability. Routine inspection of your pervious surfaces will allow you to monitor any buildup and assess performance.

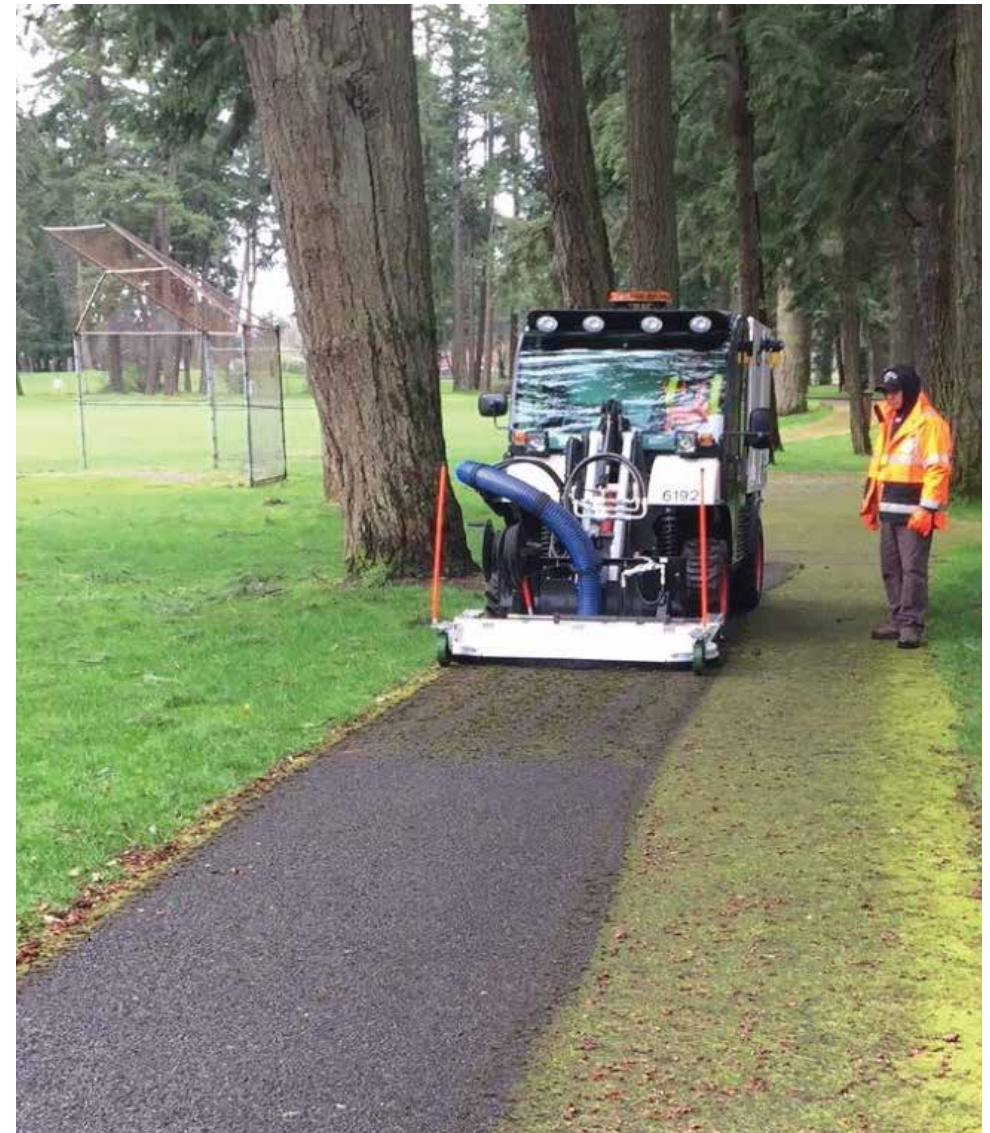
Pervious pavement clogs from the bottom up.	Pervious pavement clogs from the top down. Organic and inorganic deposits break down on the surface and clog the permeable structure's voids.

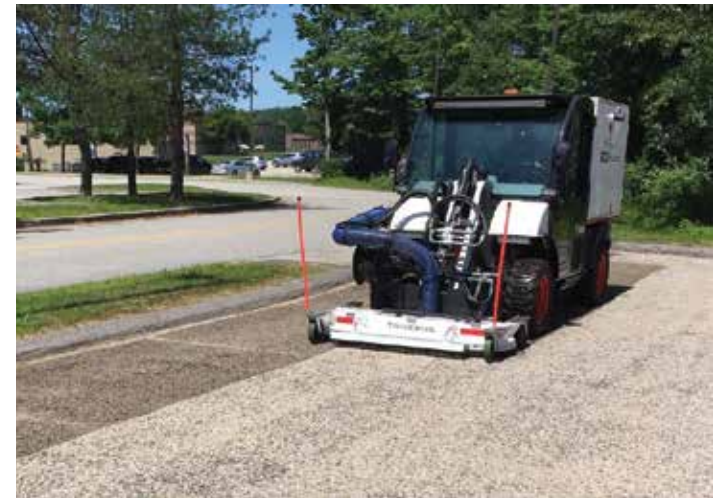
A Triverus MCV cleaning pervious asphalt at UNHSC

A series of surface infiltration tests were conducted on various pervious pavements located on the UNH campus. These tests were performed using ASTM C1701 Standard Test Method for Infiltration Rate of In Place Pervious Concrete. This test is the industry standard for measuring pervious surface performance. Measurements were taken prior to and following cleaning with a Triverus Municipal Cleaning Vehicle (MCV), a commercially available cleaning vehicle that integrates Triverus 3800 PSI spray cleaning and recovery technology onto a Bobcat® Toolcat™ all-wheel steer carrier.

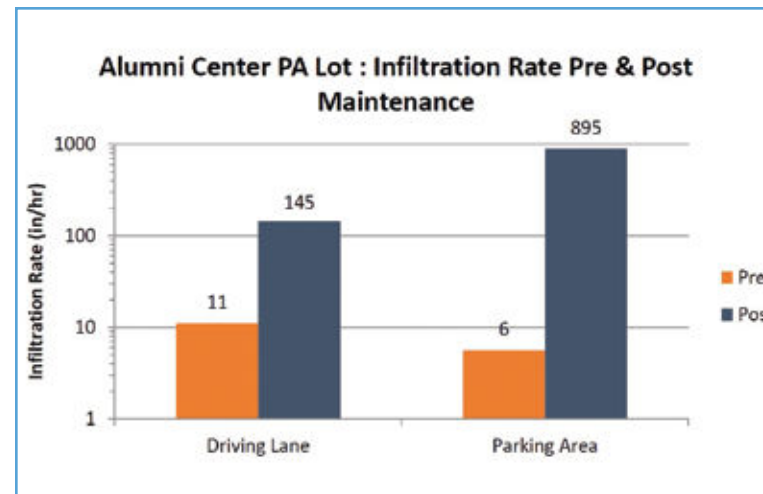
The Alumni Center lot was cleaned on July 10th, 2019. Climate statistics for Durham, New Hampshire during testing are below. The infiltration results from this testing are shown below.

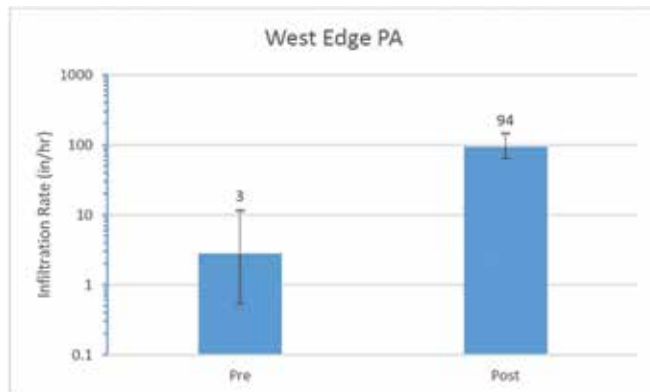
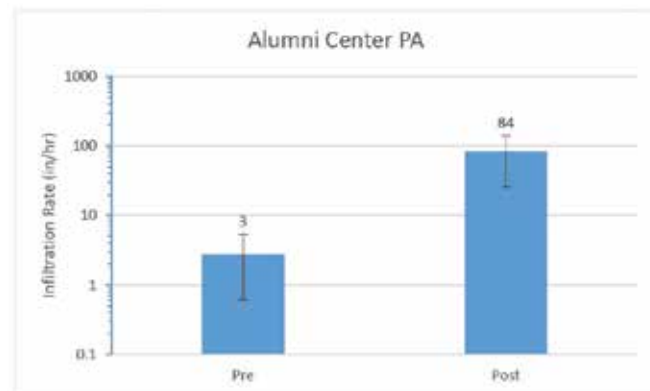
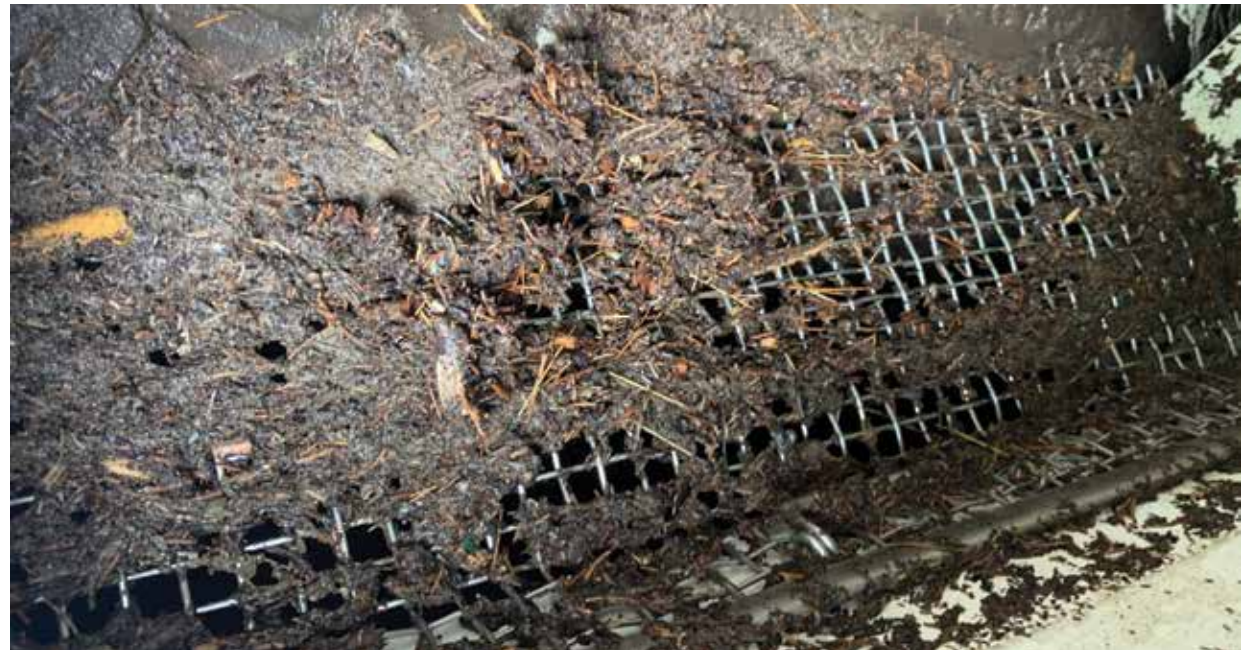
The coarse solids collected in the solids tray after several passes on the West Edge PA.

During cleaning at both sites, material was removed from the pervious surfaces by the Triverus MCV and was separated and saved for testing. The water used and recovered by the MCV during the cleaning process was also saved for testing. The coarse solids were weighed and samples collected for laboratory analysis. Grab samples of the water slurry were taken and sent as a composite sample for laboratory analysis. The restoration process was inevitably longer and more time-intensive than typical routine maintenance, but resulted in a great performance increase. The average post-cleaning infiltration rate for the West Edge lot was 94 in./hr. This is considered functional and effectively restored. The cleaning took approximately 6 hours, and 150 lbs. of coarse sediment were removed from the area. The average post-cleaning rate for the Alumni Center lot was 84 in./hr. This is considered functional and effectively restored. The cleaning took approximately 4 hours, and 350 lbs. of coarse sediment were removed from the area\*.

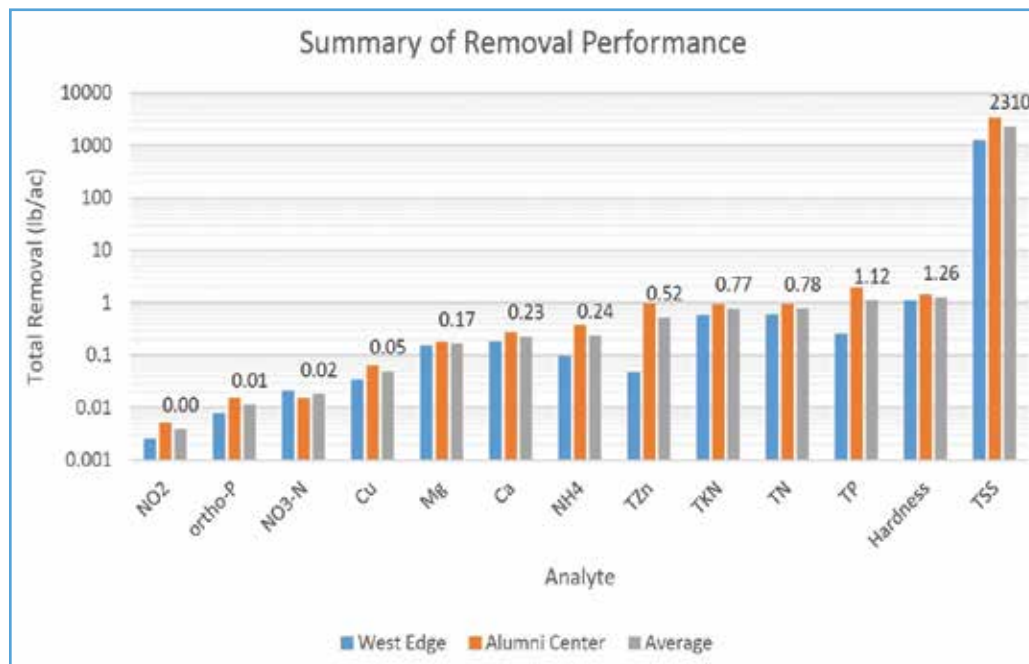
Summary of performance by site for the total removal of the solids, water, and slurry (note the logarithmic scale).

Overall, the restoration effort was extremely successful. UNHSC's research supports further exploration of restoration activities followed by more routine operation and maintenance such as vacuum sweeping twice per year. This data also reveals some significant differences in the pollutant partitioning between the liquid and solid fractions of the removed materials. It underscores the importance, particularly in nitrogen sensitive areas, of properly treating the removed waste materials. Learn more about this case study in the *Triverus Cleaning Technology Demonstration Report* by the University of New Hampshire Stormwater Center referenced in the appendix on page 11.

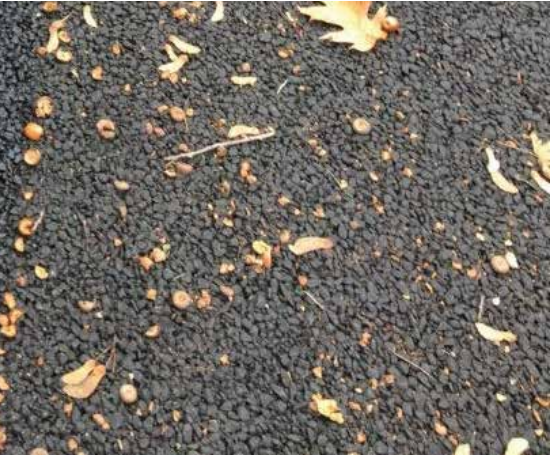
<p><b>ORGANIC DEPOSITS:</b> Organic deposits such as leaves, pine cones, and pine needles, collecting on pervious surfaces is normal.</p>	<ul style="list-style-type: none"> <li>• Cleaning with a blower (leaf blower or similar equipment), truck-sweeping, dry vacuuming, and/or vacuum sweeper fitted with water jets</li> <li>• Consistent, immediate cleaning will help prevent the need for deep cleaning or full restoration</li> </ul>

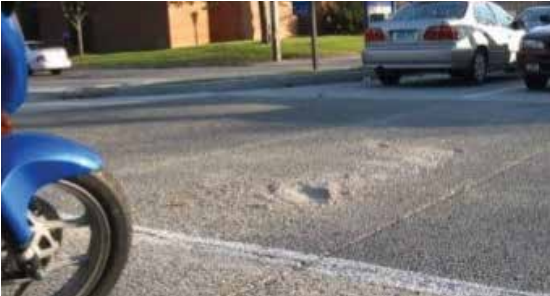
<p><b>SPALLING:</b> Spalling is caused by winter salt application leading to thawing and refreezing underneath the surface. This causes the surface to pop out, peel off, or flake off.</p>	<ul style="list-style-type: none"> <li>• Repair</li> <li>• Limit or stop use of salt in winter months</li> <li>• Initiate deep cleaning protocol prior to snowfall and cold weather</li> </ul>

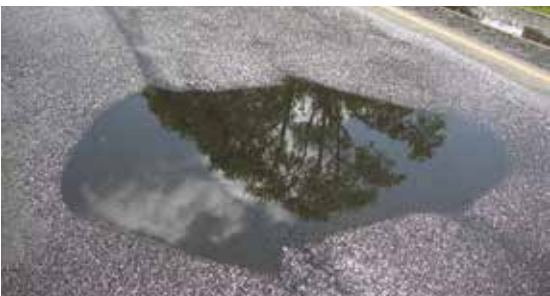
<p><b>PUDDLING:</b> Puddling is caused by clogged pavement pores, which in turn limits the permeability of the surface.</p>	<ul style="list-style-type: none"> <li>• Test with perking process</li> <li>• Remove organic and inorganic deposits by aggressive pressure washing and vacuuming</li> </ul>
